NESBITT DAM

NDS ID NO. PA-00449

**PHASE I INSPECTION REPORT
NATIONAL DAM INSPECTION PROGRAM**

JULY 1978

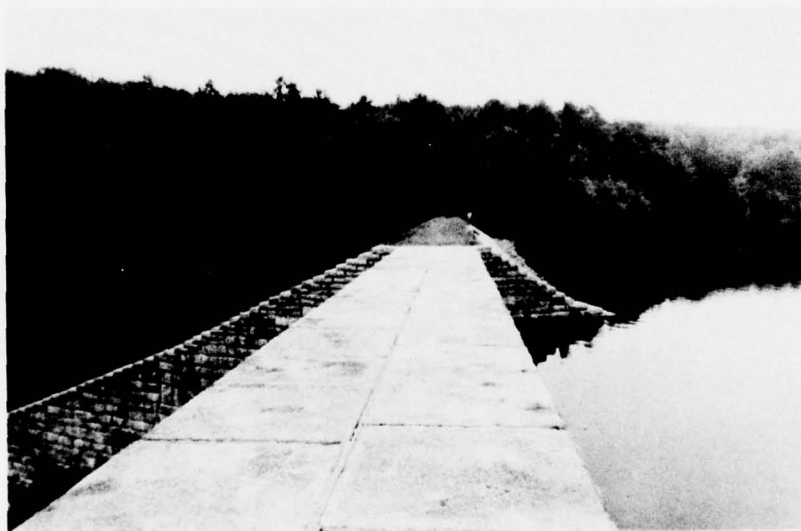
B. View Towards Right Abutment.
Nonoverflow Section, Retaining Wall, and Embankment.

The left end of the embankment and core wall terminate at a masonry gravity retaining wall which extends both upstream and downstream of the dam axis (Photographs B and C and Plate 2). Both the upstream and downstream sections of the wall make about a 70-degree angle with the dam axis such that the upstream and downstream ends are closer to the right abutment. The tops of both sections are stepped. The back, or earthfill, face of the wall is stepped on an average of 3V on 1H. The front face of the wall has a continuous batter of 12V on 1H. The wall is founded on rock, except at its downstream end.

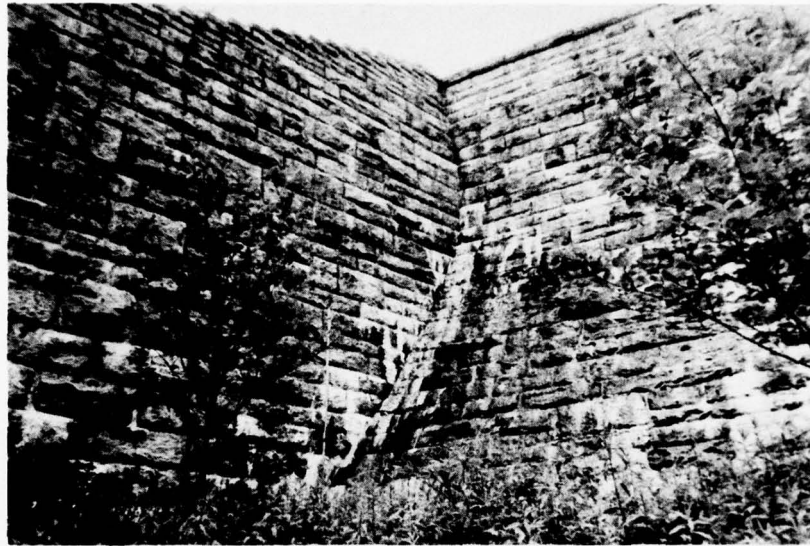
C. Junction of Nonoverflow Section
and Retaining Wall

c. Nonoverflow Section. This section is in generally good condition. Except for the top 12 feet, seepage was observed along the downstream face of the masonry (Photograph C). The seepage was not localized. Near the right end, a 2-foot square area was observed to have grass growing in the joints. Also in this area, brown-colored material was leaching from the nonoverflow section. The area of leaching was up high on the face and could not be closely inspected. A 4-inch diameter hole was observed in the earthfill at the exposed downstream toe of masonry.

(4) The retaining wall at the junction of the nonoverflow section and the embankment had three cracks. One crack started at the exposed toe of the wall at the junction of the nonoverflow section. It extended vertically through the masonry blocks for about 20 feet, which is about one-half the height of wall at this point. There was no evidence of relative movement. The second crack started at the exposed toe of wall about 3 feet downstream of the first crack. The second crack extends through the masonry blocks vertically for about 20 feet, then it deflects 45 degrees downstream and extends along the masonry joints to top of wall. There was no evidence of relative movement at this crack. Both of these first two cracks were very fine, generally less than 0.1 inch wide. The third crack starts at the exposed toe of wall 26 feet upstream of the downstream end. This crack extends to the top of wall on a 45-degree angle towards the downstream end along the masonry joints. The downstream end of the wall has moved such that the crack measures 0.7 foot horizontally and 0.4 foot vertically. The downstream end is displaced towards the spillway channel about 0.75 foot. The wall batter upstream and downstream of the crack was about the same. At the toe of this third crack, there is a wet area which extends 10 feet downstream and 26 feet upstream. The area is 3 feet wide. It was possible to insert a surveying rod 3 feet into this wet area (Photograph E). The earthfill bounded by the spillway training wall, the retaining wall, and the nonoverflow section is overgrown with small trees.

(1) Visually monitor seepage on the downstream face of the nonoverflow section and at the left abutment. If changes are noted, take appropriate action.

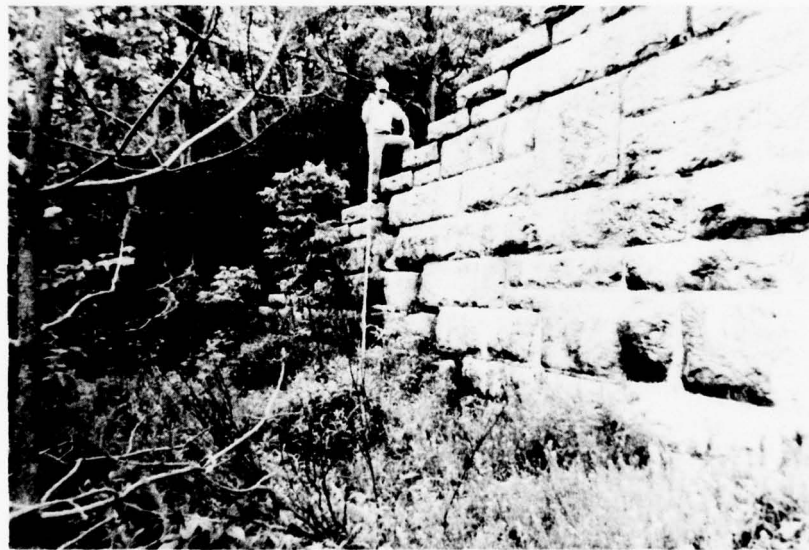
D. Crack at Downstream Toe of
Retaining Wall

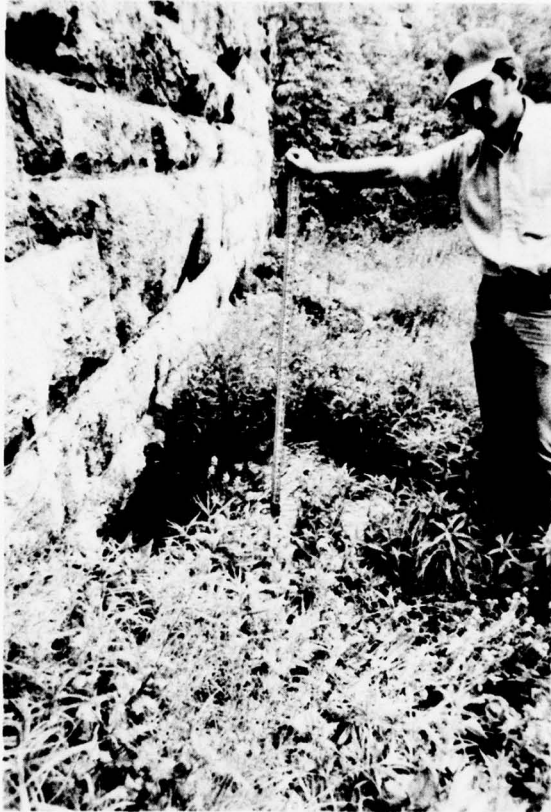
E. Wet Spot Near Downstream
Toe of Retaining Wall

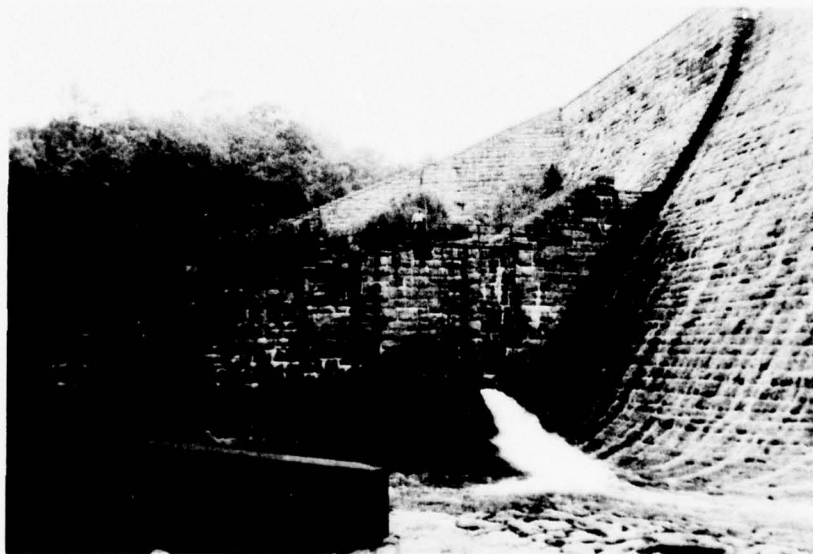
F. Spillway Training Wall
and Outlet Pipes

(5) The spillway training wall contains the outlet works. The wall was in generally good condition. One pane of frosted glass was missing from the skylight at the outlet works control structure. The operation of the outlet works valves was observed. The 10-inch valve connected to the 14-inch diameter pipe was operated easily by two men from its partially open position to its fully open position. No problems were observed with this line except a leaking valve packing. The Owner attempted to operate the four 30-inch valves. Four valve operators equipped with lever bars attempted to turn each valve. Although some of the valve stems rotated slightly, the valves could not be opened. The Owner became concerned that, if the valves were opened, they could not be closed again. This would have seriously affected the Owner's distribution system. The caretaker could not recall the 30-inch valves being operated since they were installed in 1945.

(5) Repair leaking valve packing.

(7) Replace missing pane of glass in outlet works skylight.

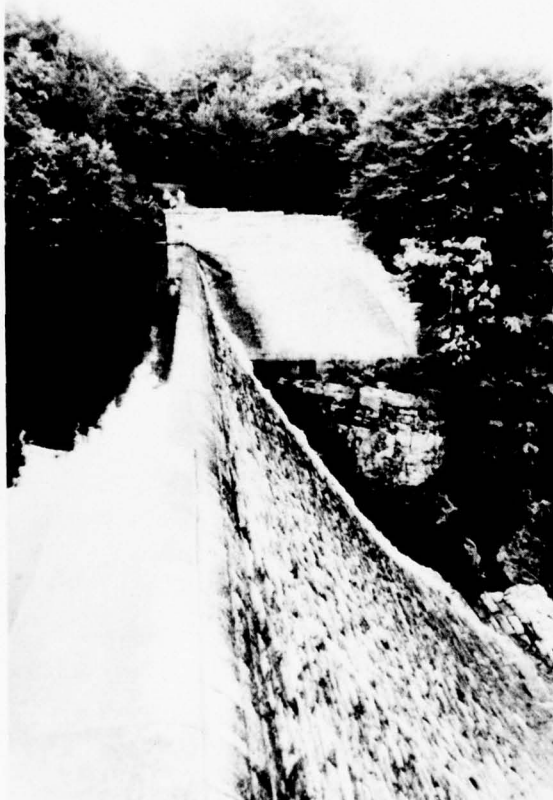
H. Spillway Crest — Looking
Towards Left Abutment

(2) The spillway auxiliary apron and auxiliary training wall were in excellent condition. Trees were growing close behind the auxiliary training wall (Photograph H).

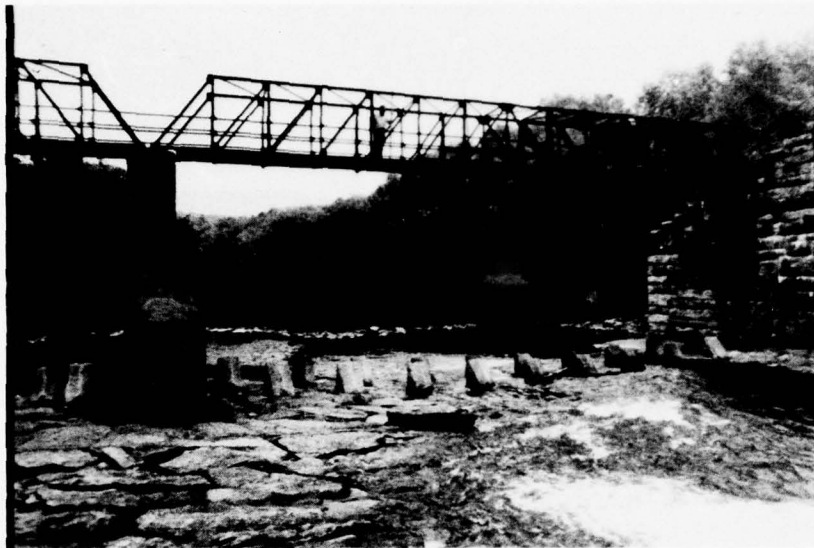
K. Spillway Apron and Bridge
Looking Downstream

(3) The spillway apron was in good condition. Mortar had eroded from some of the joints in the apron. The downstream edge of apron was slightly eroded. The wire mesh, which originally was anchored to this edge, was corroded and no longer anchored. Seepage was occurring over the entire rock face that is to the left of the apron. This seepage extended from the spillway to about 100 feet downstream of the apron. It was not localized.

(8) Repair downstream edge of spillway apron and re-anchor wire mesh.
